STATE OF HAWAII
DEPARTMENT OF LAND AND NATURAL RESOURCES
COMMISSION ON WATER RESOURCE MANAGEMENT
P.O. BOX 621
HONOLULU, HAWAII 96809

STAFF SUBMITTAL

Find that Olowalu Water Company, LLC, Owner and Operator of Diversion 961
Violated the Interim Instream Flow Standard on Olowalu Stream, and
Accept Alternative Settlement in Lieu of the Total Estimated Fines
and Order Modifications to Diversion 961,
Olowalu Surface Water Hydrologic Unit, Lahaina, Maui

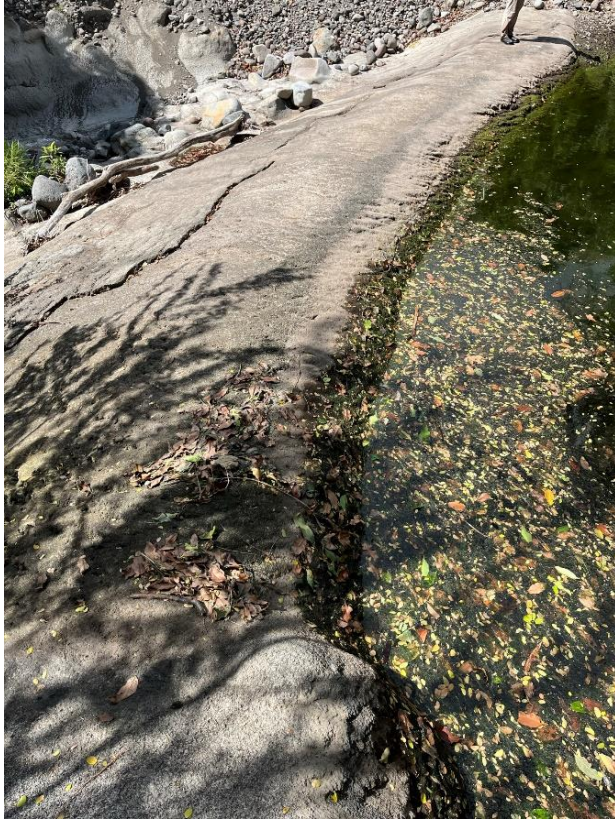
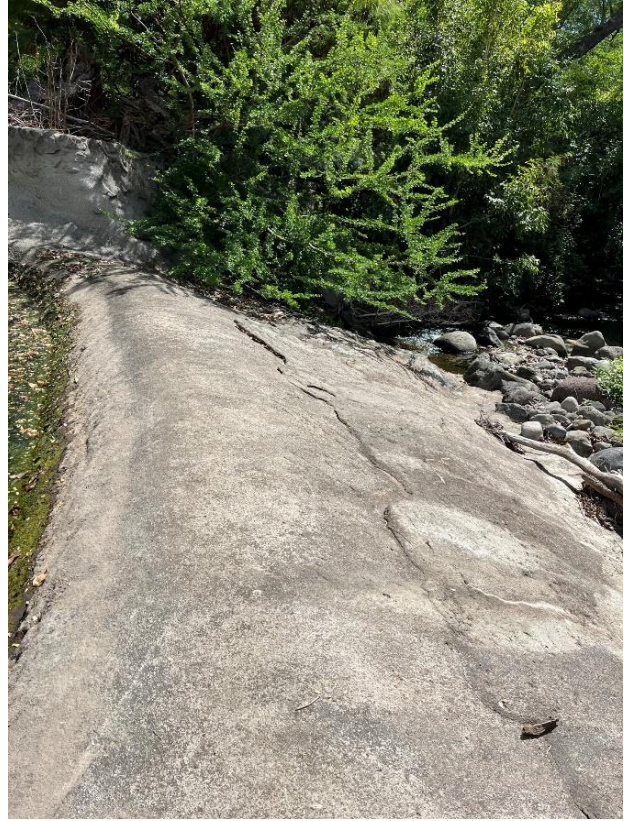
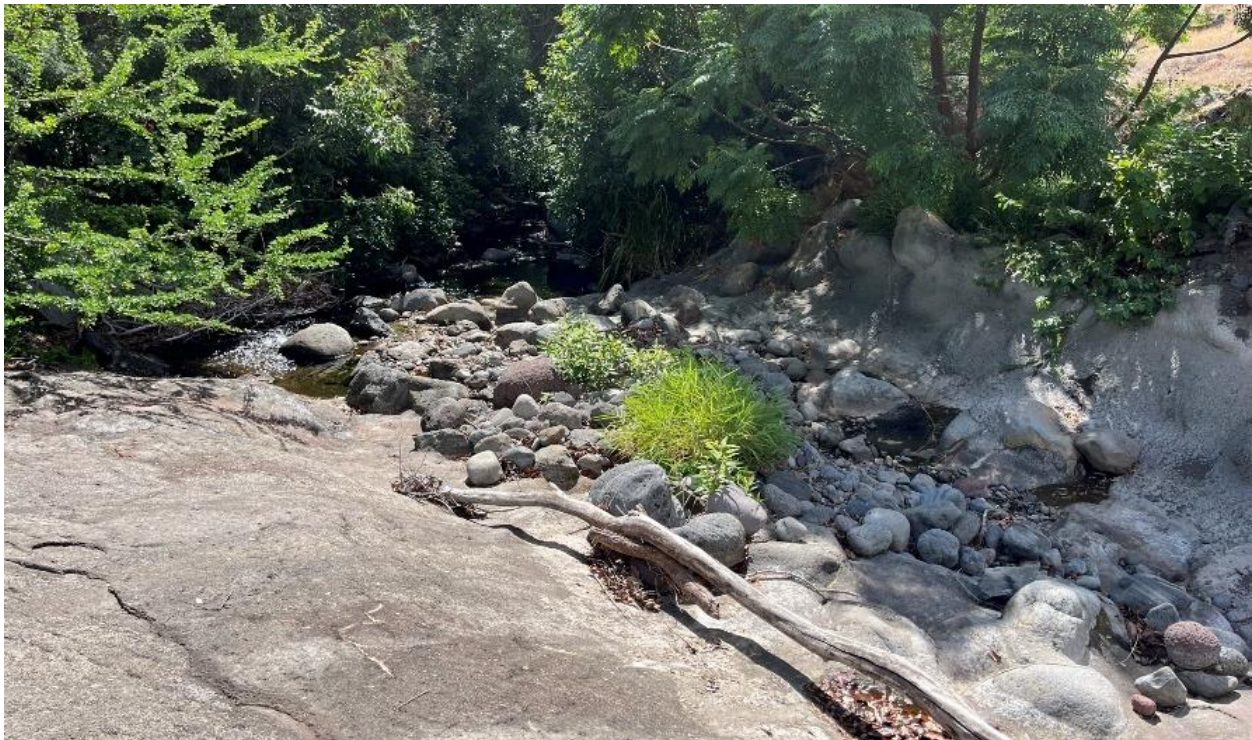
During extreme low-flows, there is leakage underneath the reconstructed dam, but no streamflow is maintained over the dam (Table 1).

Table 1. Diversion 961 on Olowalu Stream at Lower Olowalu Ditch. Top) no flow passing over diversion as viewed from left bank (left photo) and from right bank (right photo). Bottom) leakage from beneath the dam can be observed

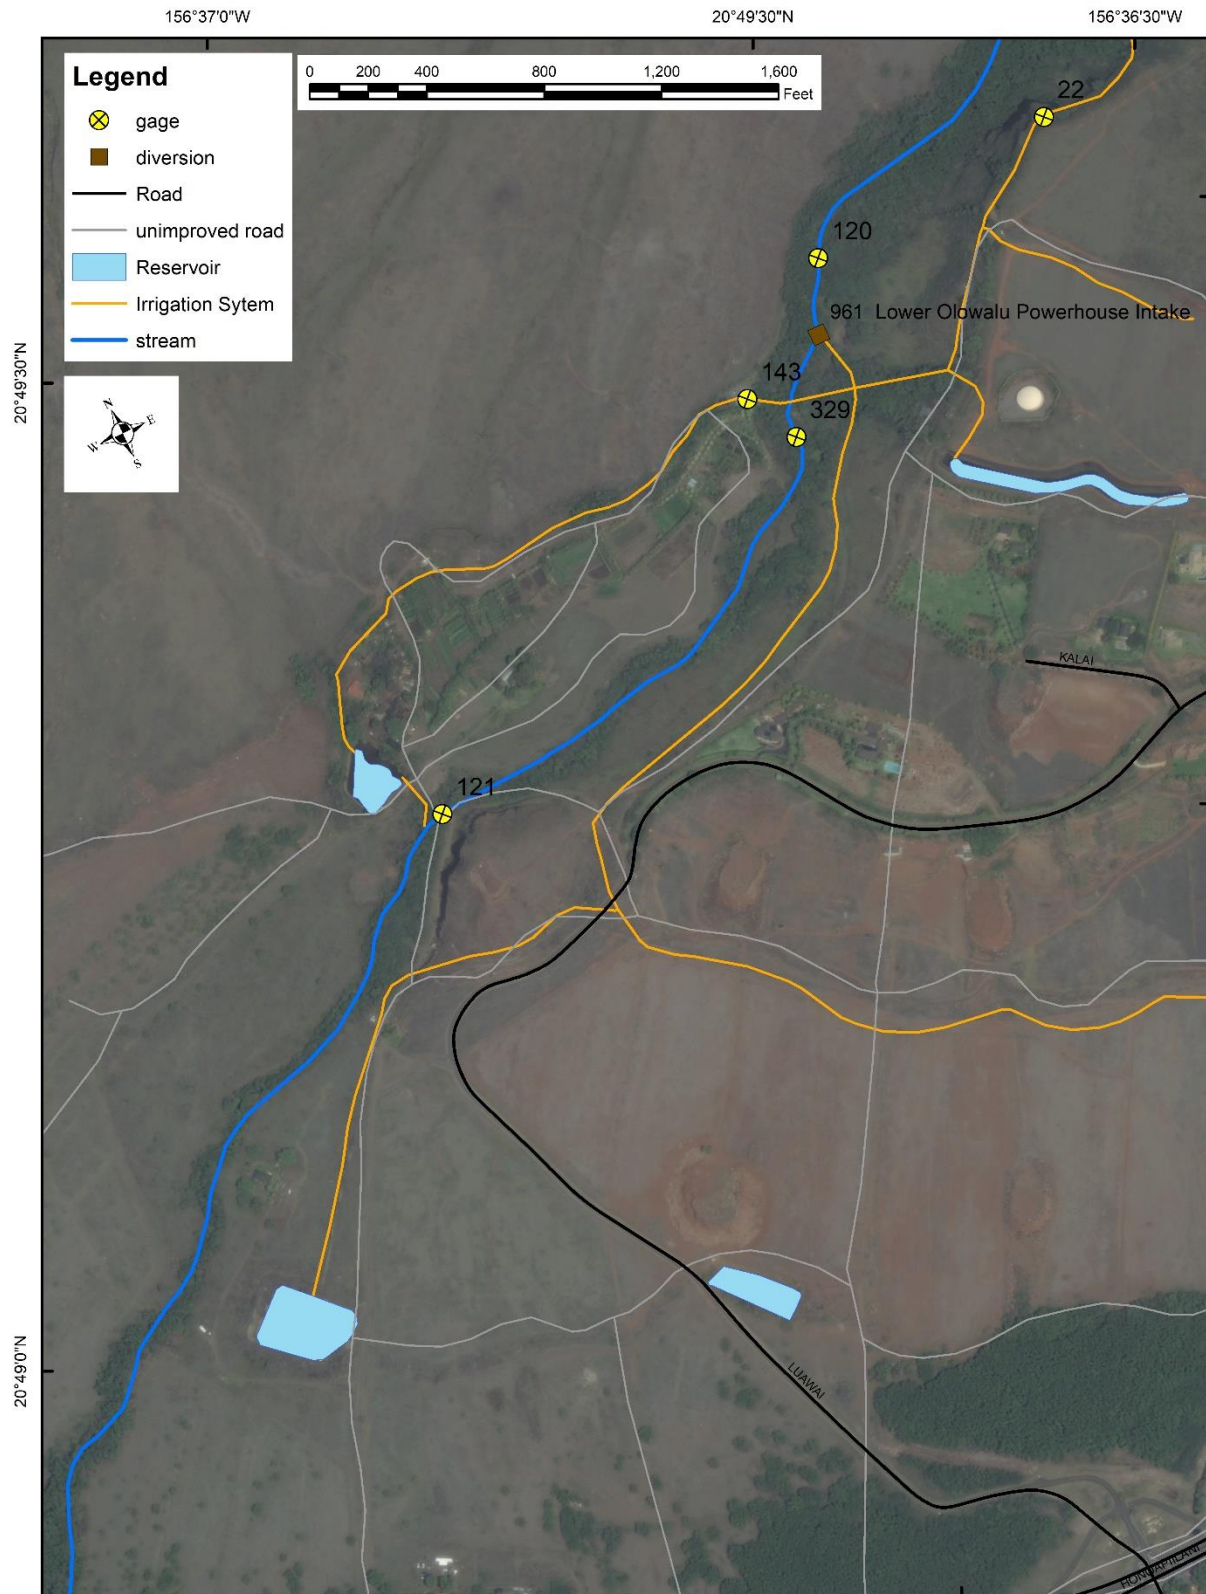
Figure 3. Map of stream and ditch gaging station locations near the Lower Olowalu Ditch including the existing interim IFS station (6-121) and the proposed new interim IFS station (6-329).

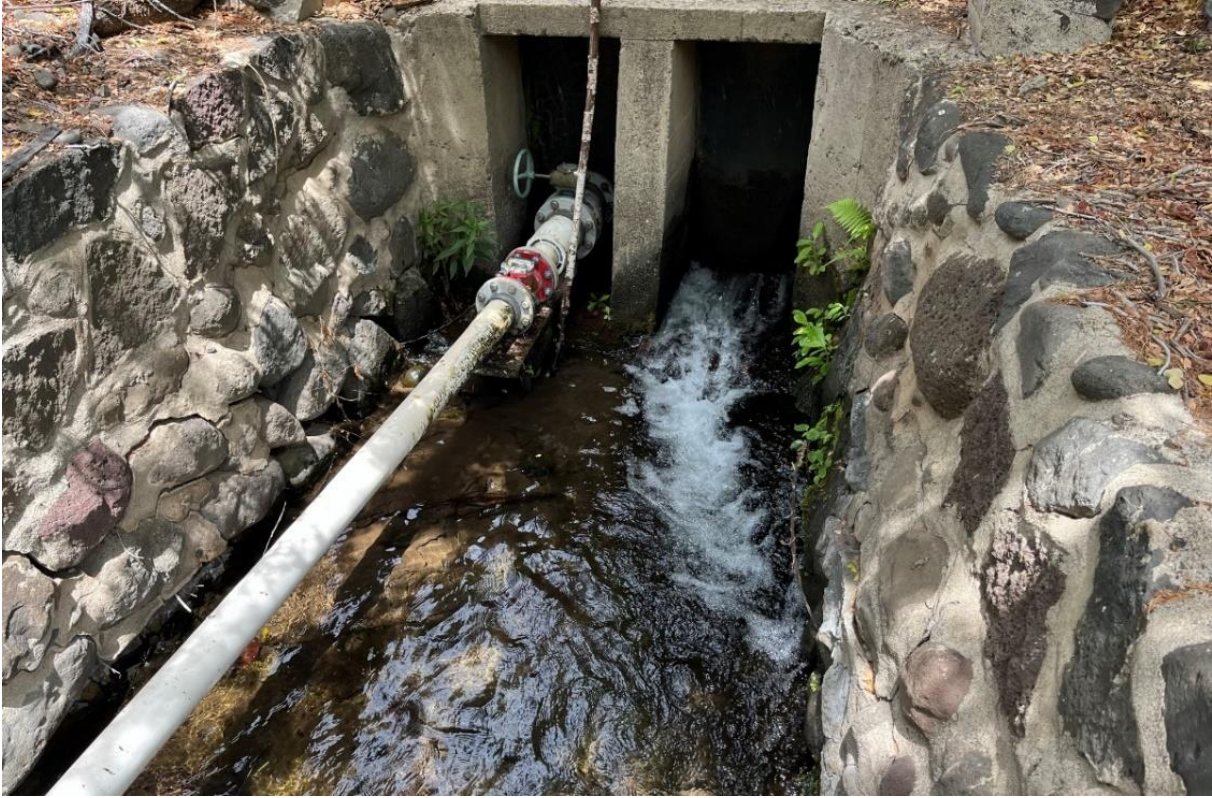
Table 3. Diversion 961 on Olowalu Stream at Lower Olowalu Ditch. A) Diverted flow at Lower Olowalu Ditch to Olowalu Cultural Reserve (pipe on left gate) and to Olowalu Water Co (right gate). B) Diversion dam from right bank with intake on left bank.

Following the Commission action to amend the interim IFS on Olowalu Stream on March 20, 2018, and Commission action to approve fines for a violation of HRS §174C-93, and HAR §13-168-32 and an after-the-fact stream diversion works permit on May 15, 2018 (see Appendix 4), Commission staff and staff from the Division of Aquatic Resources met with representatives from OWC on June 22 in the field at Diversion 961 to discuss modifications to the system in order to meet the interim IFS and provide for fish passage. Staff proposed that OWC connect a pipe directly from diversion 961 to the Olowalu Cultural Reserve to support traditional and customary practices and that a meter be installed such that an accurate accounting of the water use by OCR may be reported. This modification was completed in November 2019 as shown in the photo on Table 3A, left gate.

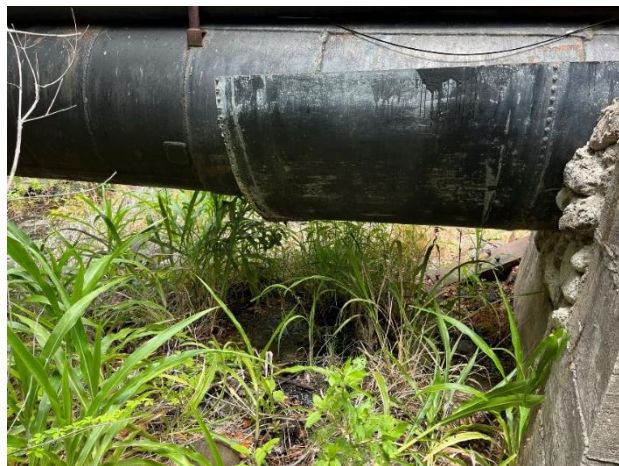
On July 11, 2022, during a site visit with staff from OWC, Commission staff pointed out three areas where diverted water was leaking out of Lower Olowalu Ditch: at the former gravel trap; on the flume across Olowalu Stream; and on the OCR pipeline at a broken pressure release valve (Table 4). In the implementation of the March 20, 2018 decision to amend the interim IFS, the Commission ordered “any party diverting water from a stream shall be responsible to maintain system efficiencies, minimize offstream water losses, and minimize impacts to the natural stream resource.”

a) Water leakage from Lower Olowalu Ditch flume

2. **Repairs.** The leak at the ditch sluice gate next to the debris grating was repaired prior to the October 18 CWRM meeting. Repairs were also made to the OCR air breather. OWC completed a walk-through of the ditch, and filled some cracks and removed some vegetation. The flume was cleaned and re-sealed. Finally, green mountain grout will be injected into the intake and head wall. The grout is environmentally safe and used as a solution for large dams around the world and potable water systems. The grout is being air freighted to Hawai'i. OWC expects to receive the grout on Wednesday, November 9 and is waiting on approval from the U.S. Army Corps of Engineers. The U.S. Army Corps of Engineers has indicated that a permit will likely be necessary for damming of the Stream.

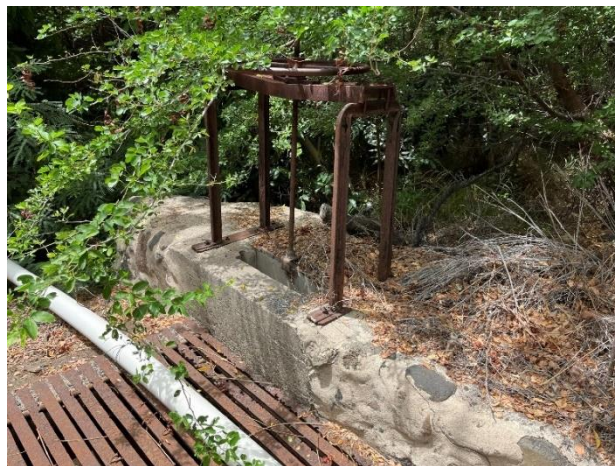
b) water leakage from Lower Olowalu Ditch sluice gate.

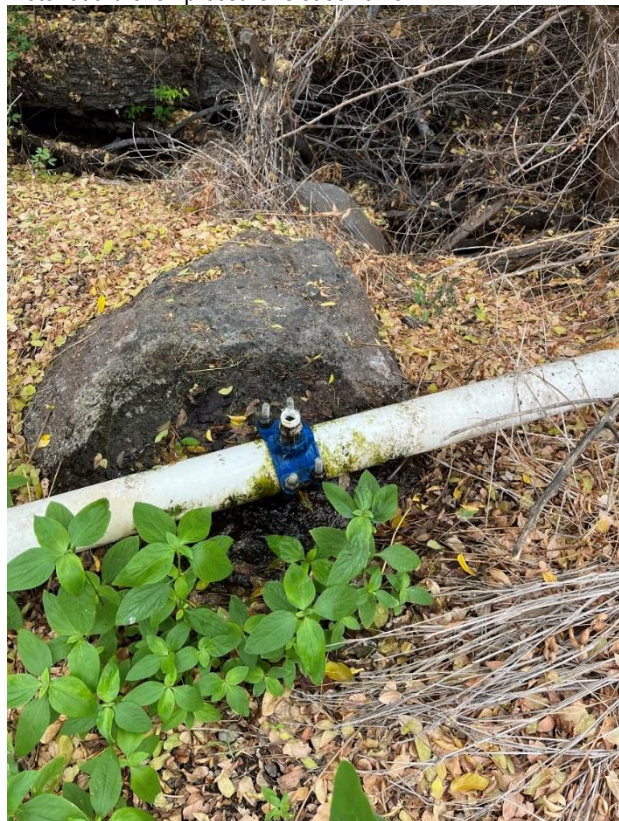
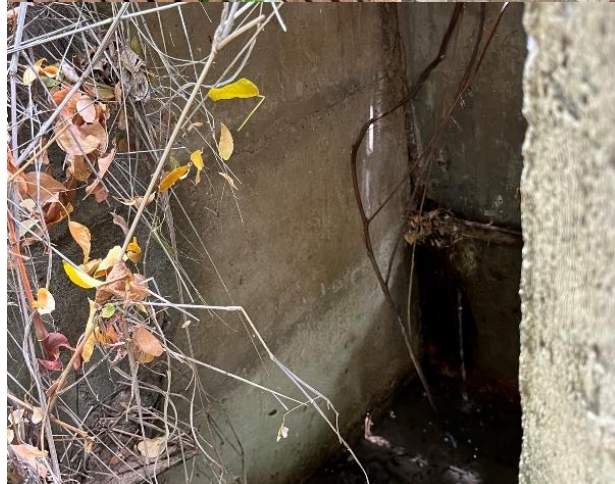
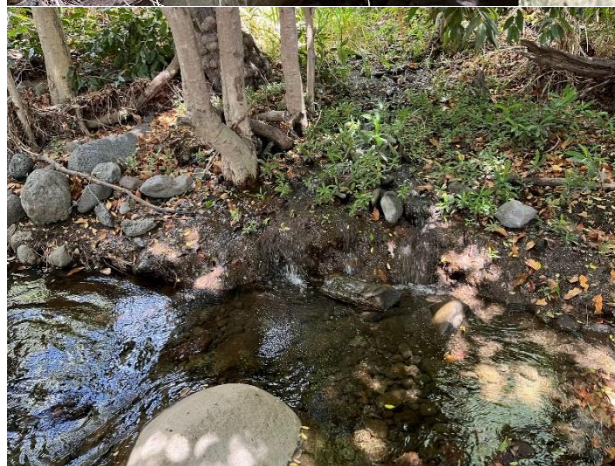
c) Leakage from Olowalu Cultural Reserve pipeline below meter at a broken pressure release valve

1. Olowalu Water Company will provide the Olowalu Cultural Reserve with a functioning sand filter for the OCR pipeline to reduce blockage and subsequent leakage from their irrigation system within 6 months of approval.

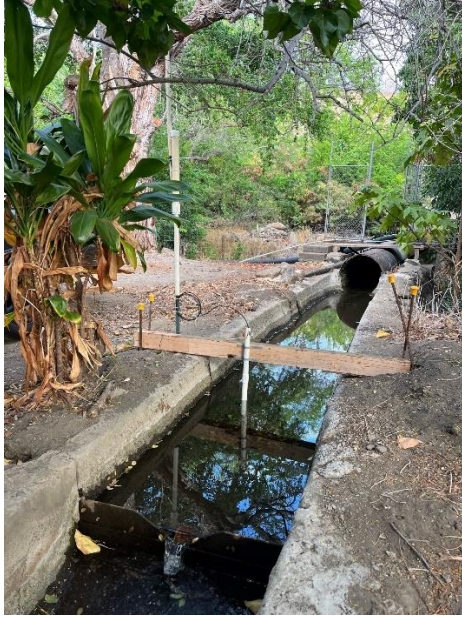
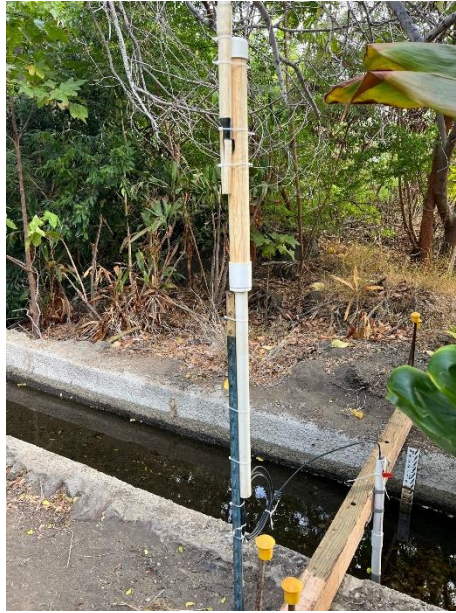
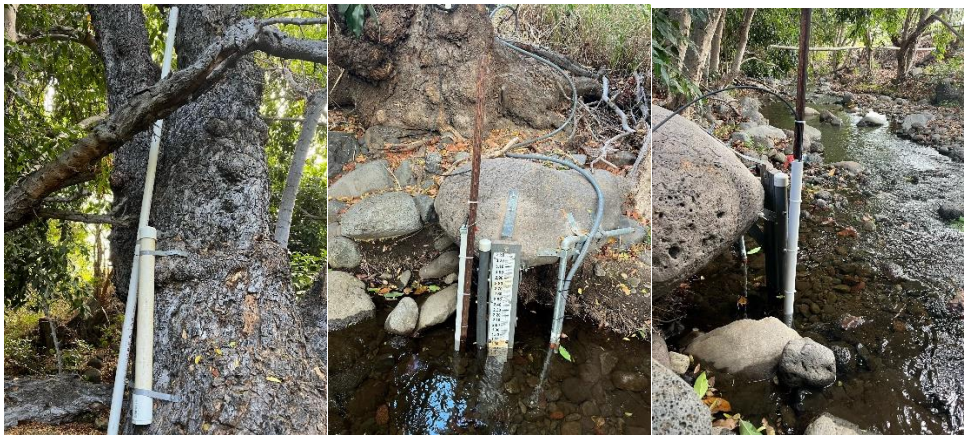
1. **Stream Flow Gage.** Two cellular data rental loggers were installed: one at the v-notch and the other in the stream (about 2 feet behind CWRM's sensor below the flume). OWC purchased two loggers (\$6500 plus \$40 per month for cellular service). The rental loggers will be replaced when the purchased loggers are received. The information from the data loggers will be shared with CWRM Staff so that Staff and OWC will know the amount of water diverted and the amount of water remaining in the Stream (in conjunction with existing CWRM gages). Current cellular service is not being reliable, antennas were ordered and will be installed and tested within 14 days. The flow formula and calibration needs to be completed. OWC will work with consultants to finalize.

Photographs of the installed data loggers are below.

V-Notch Data Logger

Stream Data Logger

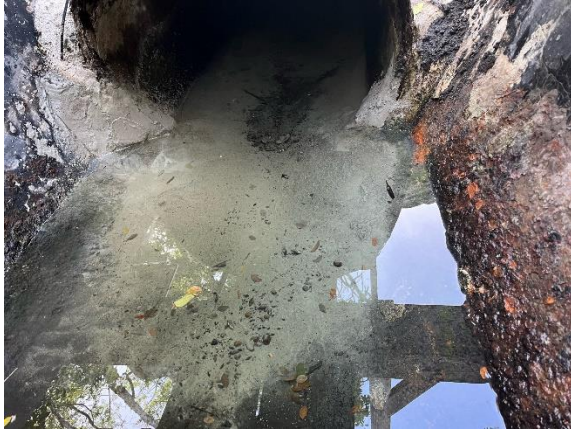
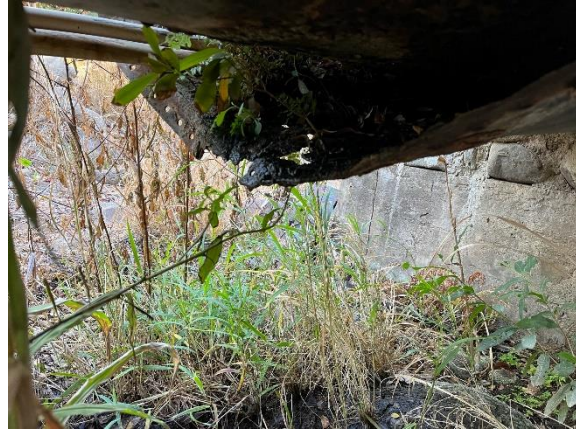
Above are photographs of the flume repair.

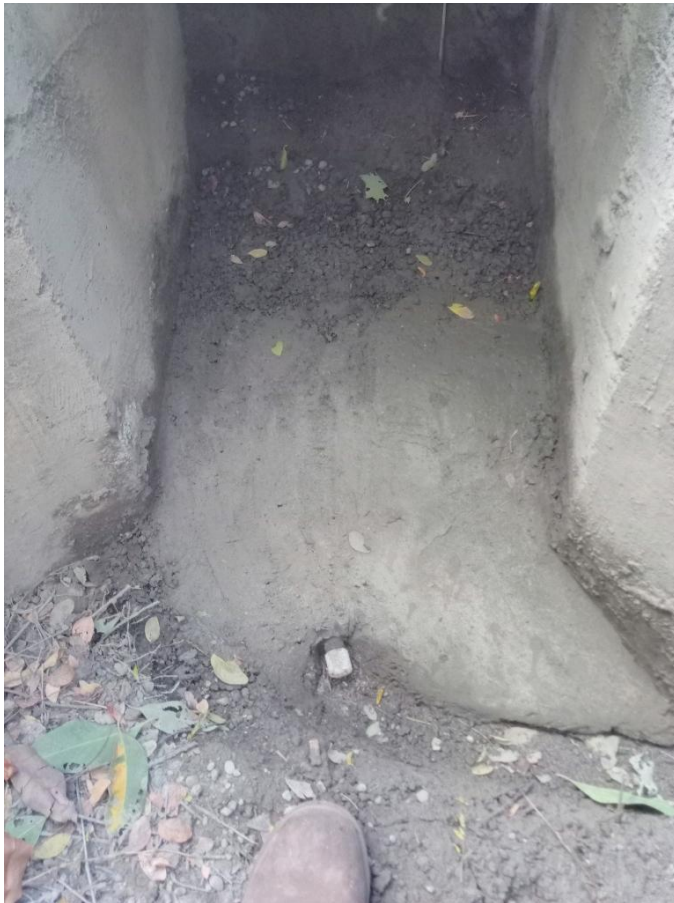
To the left is a photograph of the grate repair.
